Geological and Geotechnical Assessment Report along Cut Slope in Connection with Barkhera– Budni 3rd Line Project Bhopal

Pooja Swami^{1*}, Dr. Pallavi P. Khobragade², Rishi Sharma³,
Dr. Ritambhara K. Upadhyay⁴

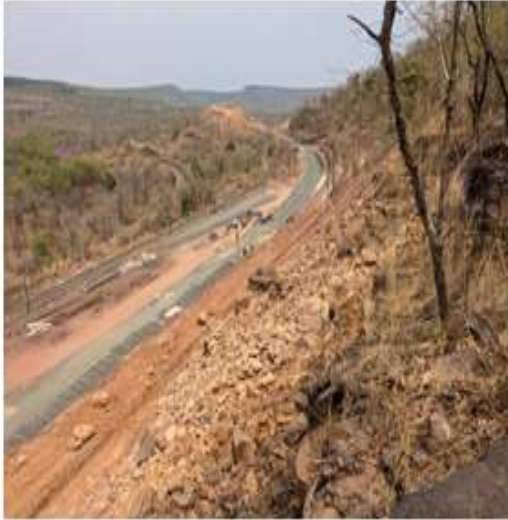
Figure 2: Slide from Ch.10+820 to Ch.10+960 Km with potential rockfall hazard.

Several instability zones have been identified during surface geological mapping, including five major slides (Slide-1 to Slide-5) occurring at different chainages, particularly near bridge abutments, tunnel portals, and cut slopes formed after benching. Failure slopes range between 40° and 50° , and the failed mass typically comprises boulders, cobbles, and sandy–silty matrix, indicating debris-type slope failures. Certain stretches show complete absence of rock outcrops, with the terrain entirely covered by loose slope wash and large boulders.

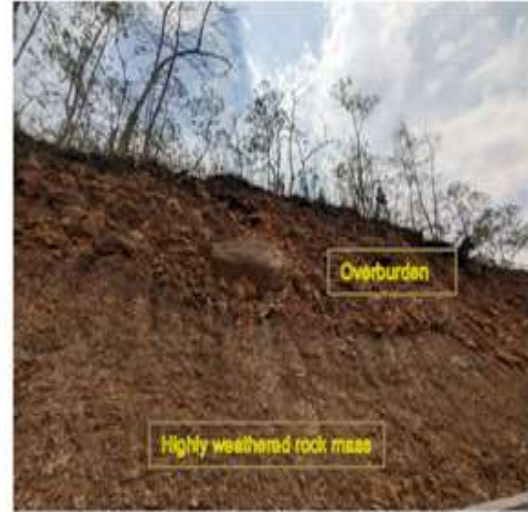
Figure 3: Unstable zone at the top of slope between Ch. 12+850 km and Ch. 12+950 km.

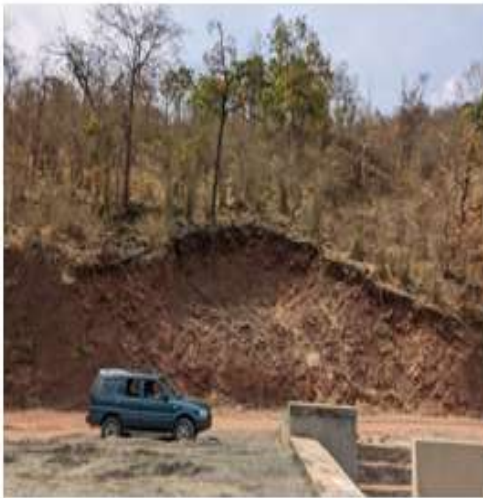
Figure 4: Slide Near to Bridge No. 27

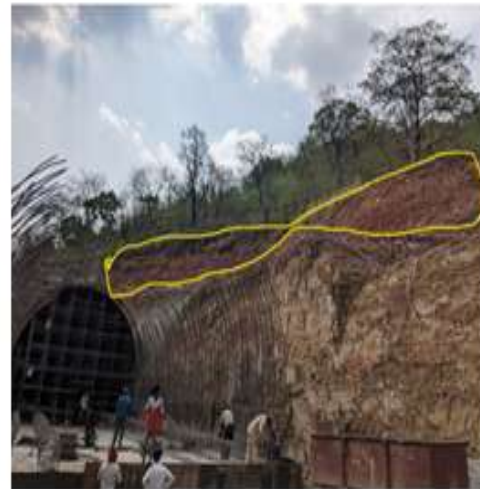
Figure 5: Unstable zone and Shale at Portal-2 of Tunnel No.2

Critical zones are observed near Tunnel No. 2 (Midghat tunnel) and the proposed Tunnel No. 3, where unstable overburden, thinly foliated shale, subsidence-related failures, and large unstable boulders (up to 10×15 m) pose significant hazards. Seasonal nala activity and debris accumulation further increase the likelihood of rockfall and slope instability during monsoon periods. Although groundwater conditions are generally dry, the high degree of weathering, weak rock mass conditions, and presence of heavy infrastructure such as railway tracks, bridges, tunnels, and proposed cut-and-cover sections make this stretch highly vulnerable and require detailed slope stabilization and mitigation measures.

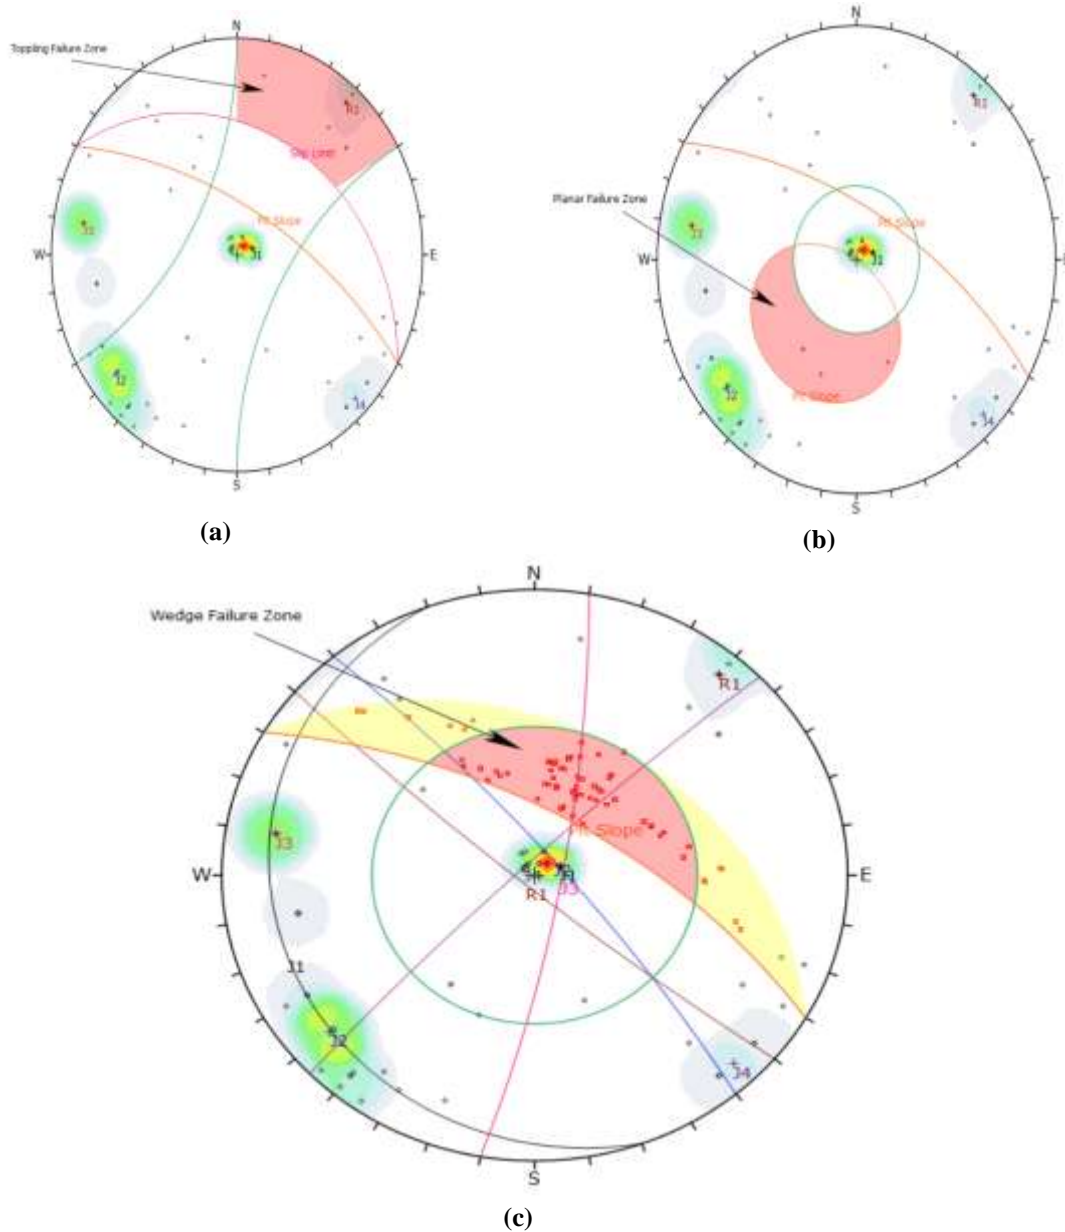
Figure 3: Stereographic projection for (a) Toppling Failure Zone; (b) Planar Failure Zone; (c) Wedge Failure Zone at Ch. 14+300 Km

Table 2: Details of Joint Set for Ch. 14+300 Km

Set No.	Dip Amount (°)	Dip Direction (°)
J1/Foliation	10	250
J2	81	050
J3	80	100
J4	85	316
R1	85	220

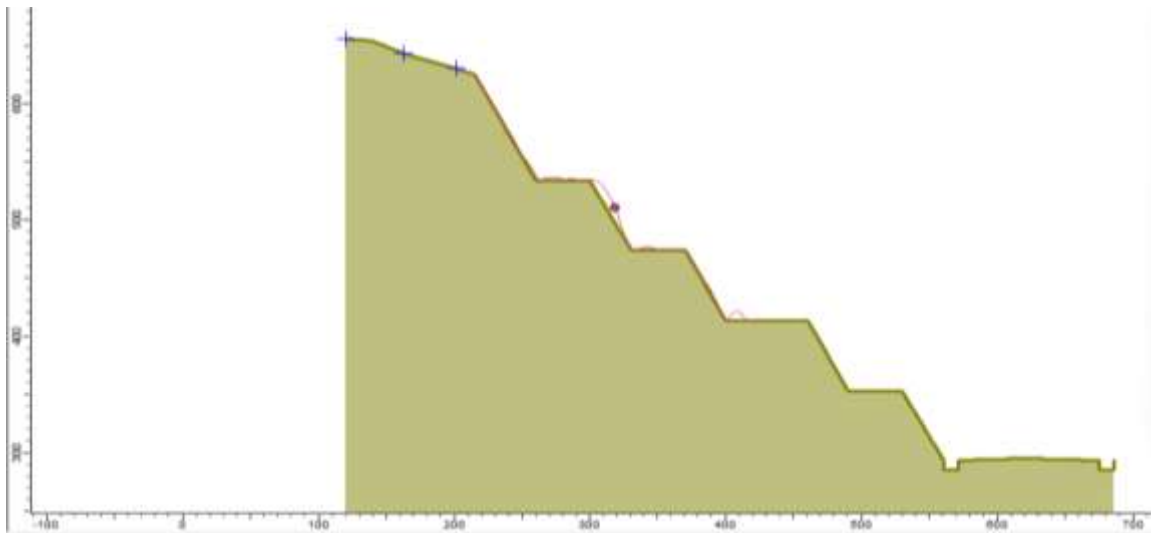
Figure 4: A simulation of a falling boulder

Rockfall modelling was carried out using RocFall 2D, developed by Rocscience Inc. The program applies rigid body analysis to simulate block trajectories, velocities, energies, and run-out distances. Surface parameters such as restitution coefficients, friction, and roughness were selected based on field observations and published data for similar geological conditions.

Two categories of rock blocks were considered: small rocks (1,000 kg) and large rocks (10,000 kg), both with a density of 2,700 kg/m³ and varying geometrical shapes. A total of 1,000 blocks were simulated from three critical release locations without any protective measures to assess the worst-case scenario.

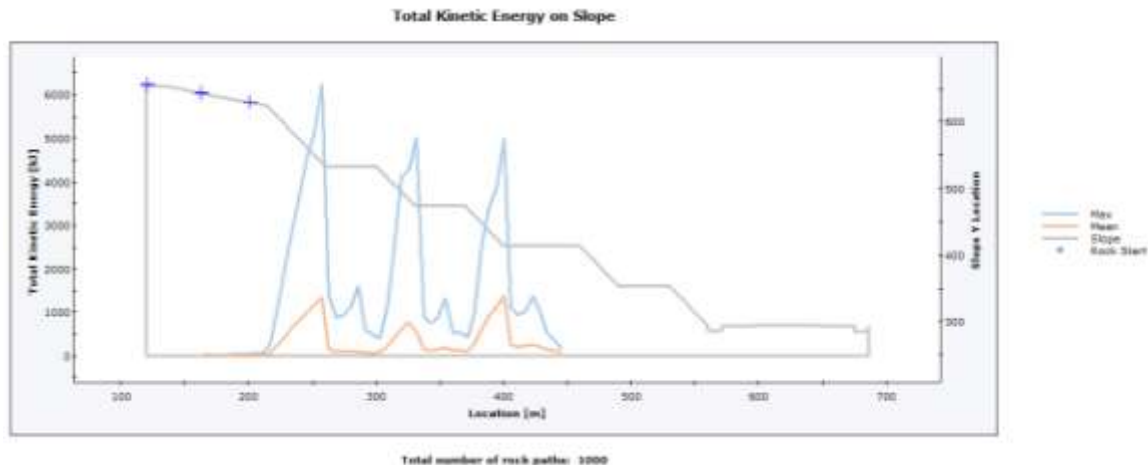
Figure 5: Total Kinetic Energy on Slope

The results indicated a maximum bounce height of 20.22 m and a maximum total kinetic energy of 5,041 kJ. The high translational energy component suggests a significant risk of impact on the railway track.

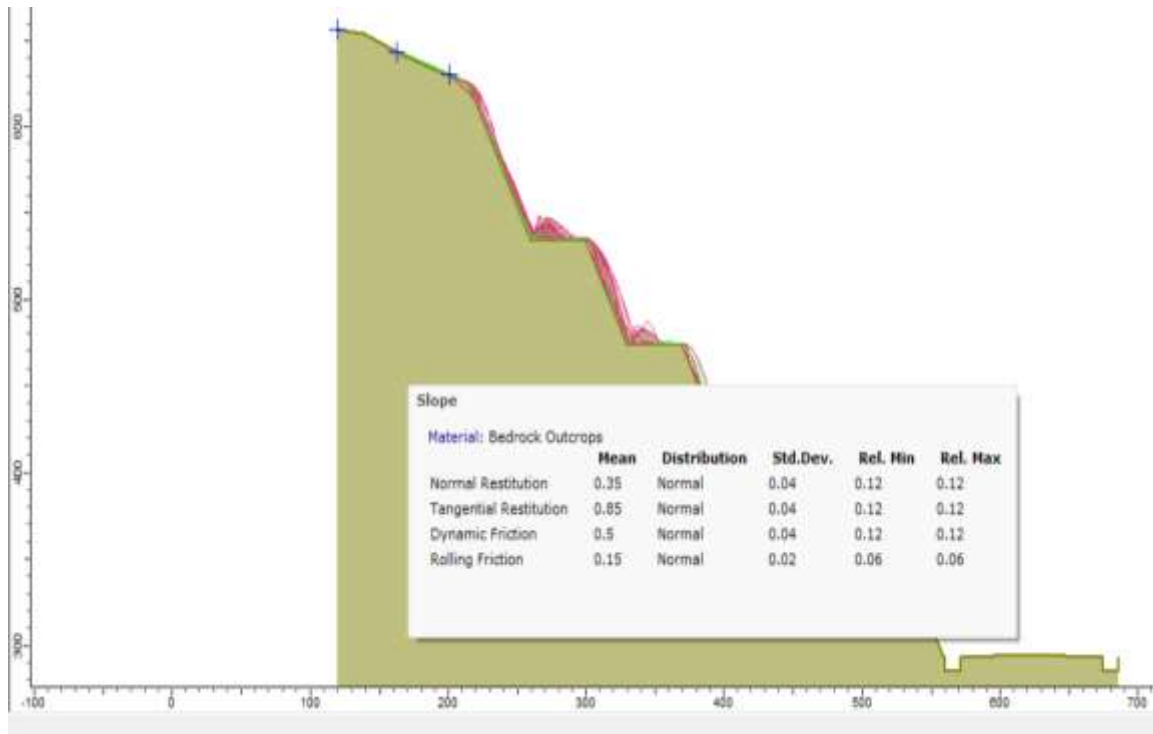
Figure 6: Material Properties

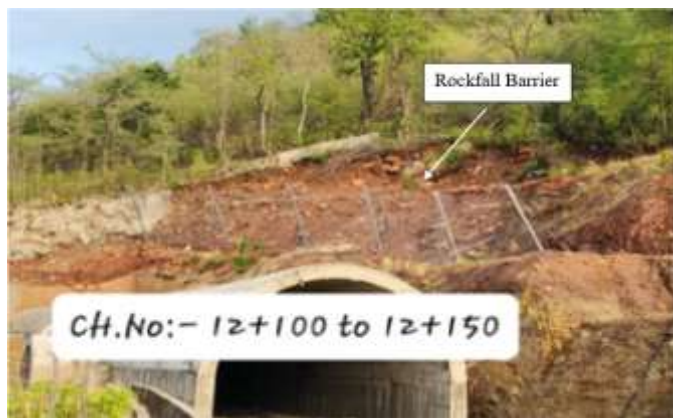
Figure 7: Installed Rockfall barrier at Tunnel Portal
(Photo Source: RVNL Report)

Rockfall trajectory analysis identified critical sections where falling blocks could reach the railway corridor. Flexible rockfall barriers were installed at these locations to absorb and dissipate impact energy, thereby ensuring operational safety.

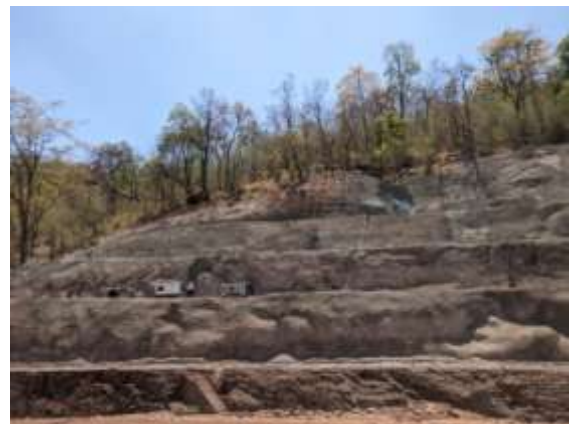
Figure 8: Cut Slope Stabilization

- **Cut Slope Stabilization:** The cut slopes were found to be affected by weathering, discontinuity-controlled failures, and water infiltration during monsoon periods. To improve surface stability and prevent raveling, a 100 mm thick shotcrete layer reinforced with welded wire mesh was applied over vulnerable slope faces. In highly fractured zones, heavier mesh was adopted.

For structurally controlled failures such as planar, wedge, and toppling modes, fully grouted 25 mm diameter, 6 m long self-drilling anchors were installed at 1.2–1.5 m spacing. These anchors enhanced block interlocking and increased shear resistance along discontinuities.

To control the adverse effects of groundwater, sub-horizontal drainage holes fitted with perforated PVC pipes were provided in a staggered arrangement. This reduced pore water pressure within the slope mass. Additionally, a reinforced concrete toe wall was constructed at the slope base to provide passive resistance and protect the railway track from minor rockfall and debris accumulation.
