# Rehabilitation and Repairing of Reinforced Concrete Structure

Varun Kumar Sikka<sup>1</sup>, Laxman<sup>2</sup>

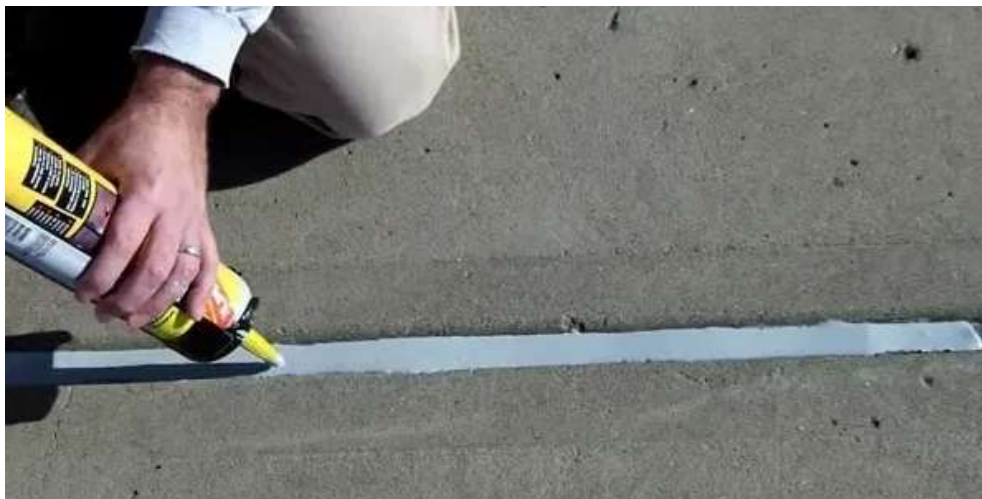
Crack sealing in concrete buildings may be accomplished with a variety of commercial sealants. Structural integrity and serviceability may be ensured by using joint sealants. Toxic liquids, gases, and other undesired contaminants can degrade the quality of concrete if they are transported there (Panigrahi et al., 2014) Initially, the fissures are expanded along the face and pointed with screened material when the damaged surface is restored.

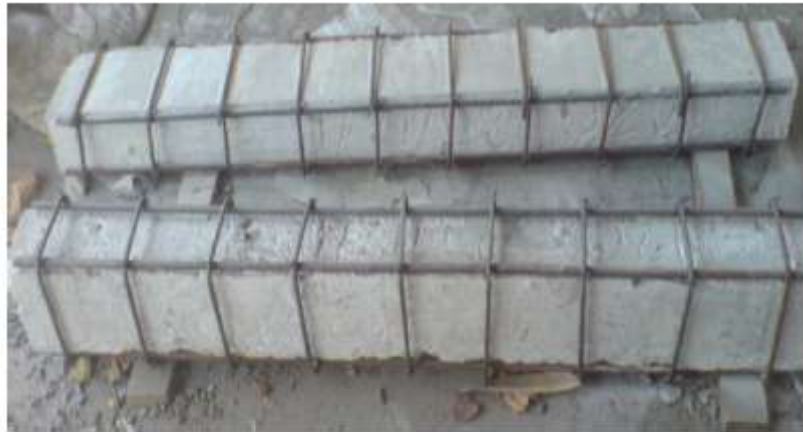
Concrete jacketing was used to increase the strength of the cast reinforced concrete beam test specimens. Adding reinforcement to the beam specimen is accomplished by lightly chopping the surface, after which it is filled in concrete on all sides by placing it in the mould. After a day, it is taken out of the mould and submerged in water for 28 days to cure before being tested. External jacketing with 2 Nos of 10mm diameter @ top and bottom and 6mm diameter stirrups spaced @ 175mm c/c strengthens and rehabilitates reinforced concrete beams cast with M20 grade concrete.

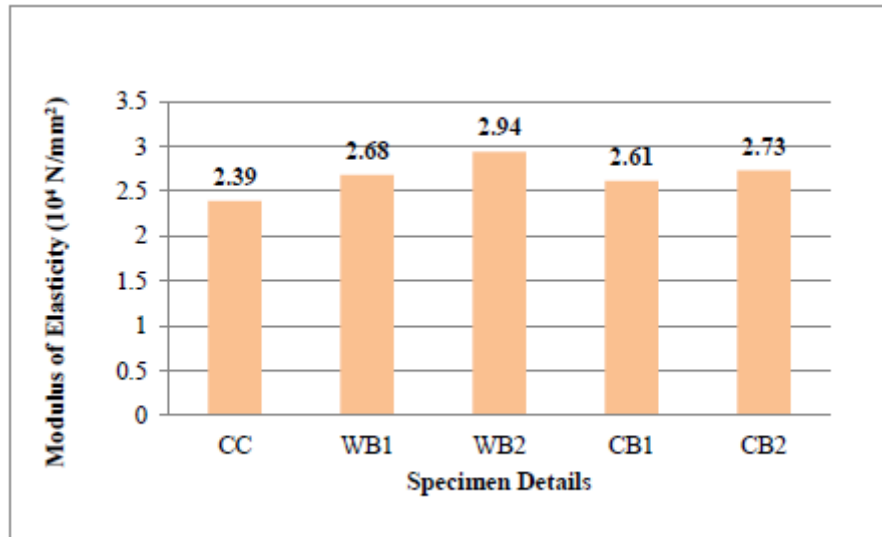
**Modulus of Elasticity values**

Roving mat in two layers has a higher modulus of elasticity of roughly 1.23 times that of the control prism, as shown by the above study on modulus of elasticity.

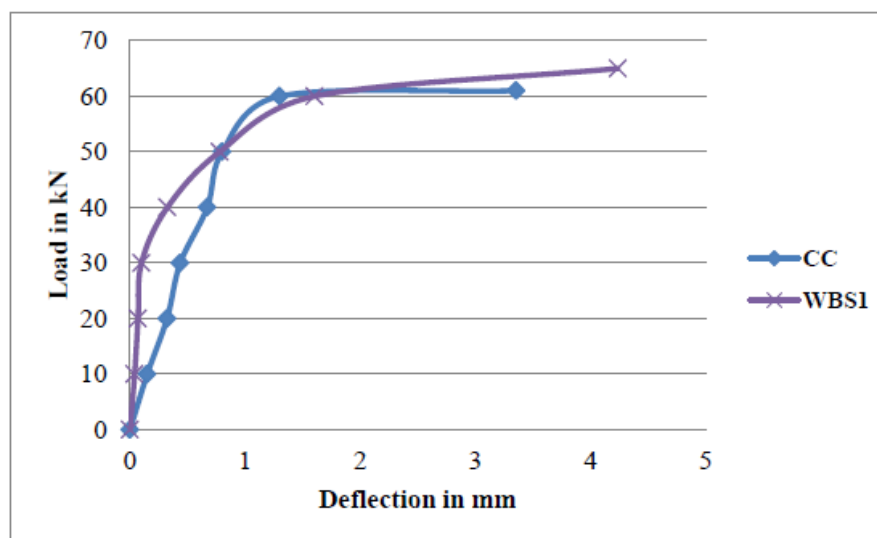
**Beam WBS1 Load-Deflection Curve**

Compared to all beams, including the control specimen, the descending part of WB2's load-deflection curve has a less steep slope. All types of reinforced beams have a high load carrying capacity in the final stage. Although WBS1 was the strongest beam, it could only deflect 4.239mm at its highest point, while beams WB1 and WB2 both deflected 3.37mm and 4.232mm.

There was a maximum deflection of 4.232mm in Beam WB2 and 3.519mm in Beam CB2 when they were loaded to 85.00kN and 84.00kN, respectively. While the woven mat did not tear out while applying the load, both wrapping patterns had adequate bonding with the specimen and finally disperse the weight across the entire tension zone.
